Manhole Inspection Summary

Manhole # S55S__004MH

Insp Date: **3/17/09 8:14 AM**

Location Address: **1516 S HIGHLAND AV**

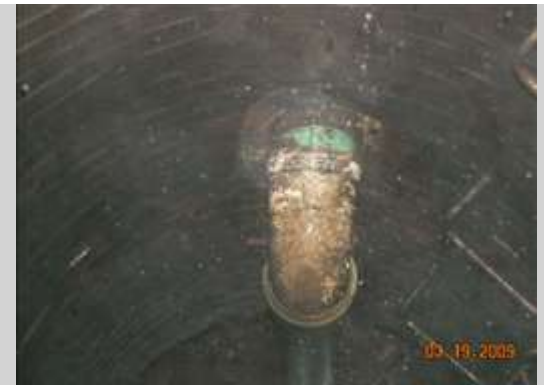
3 O'Clock Inflow

Pipe Height: **8.4** (in.) Rod and Bar (Angled)
Pipe Material: **Clay** ☐ Pipe Lined
Invert Depth: **9.40** (ft.) Flow Characteristics: **Slow**
Deposits: ☒ None ☐ **Mud** ☐ **Gravy** ☐ Debris ☐ Grease
Silt Depth: **0** (in.) Deposits Extent:
Infiltration: **None** Pipe Seal Cond: **Sound**

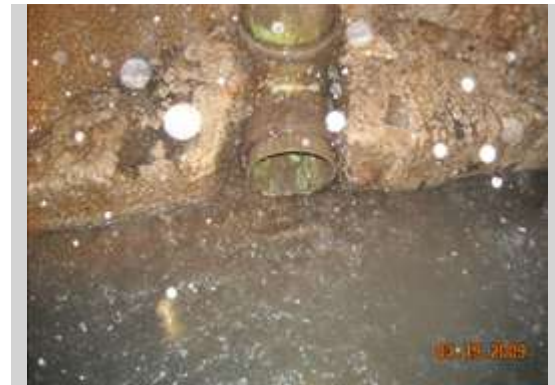
Drop In @ 3 O'Clock

Drop: **Inside** Rod and Bar
Angled: **Yes** Reading: **19.40** (ft.)
Inv Depth: **20.40** (ft.)
Drop Condition: **Open**
